GENx-2B SERVICE BULLETIN - 73-0089 R01Revised:
01/11/2021SB 73-0089 R01 ENGINE FUEL AND CONTROL - FUEL NOZZLE MANIFOLDS (73-11-40) -
TOP MAIN FUEL MANIFOLD AND LOWER FUEL MANIFOLD INSPECTION - POST-GENX-2B S/B
73-0038Issued:
05/08/2020

TRANSMITTAL INFORMATIONREVISION 1 TO SERVICE BULLETIN 73-0089

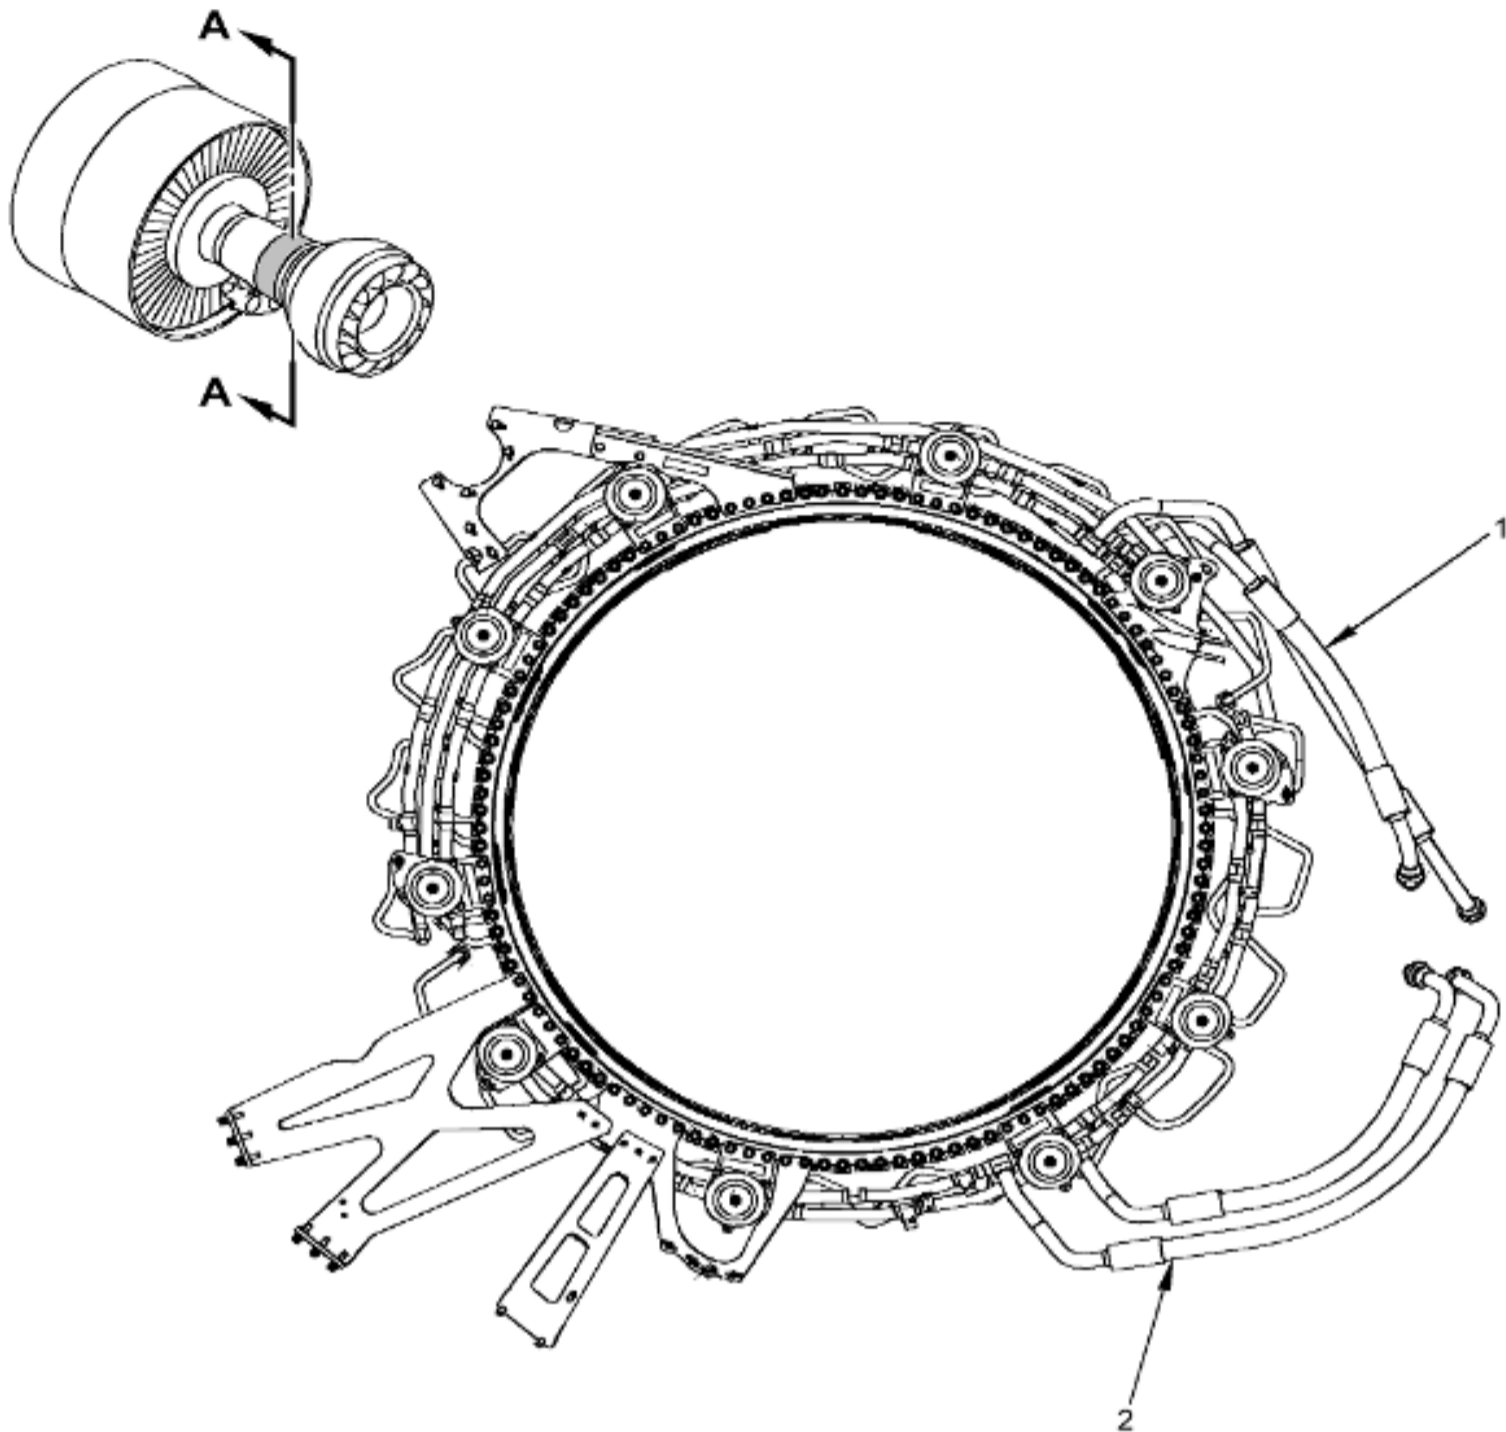
Top Main Fuel Manifold and Lower Fuel Manifold Location
Figure 1

A crack in a lower fuel manifold segment was found in service. The crack was found in the secondary fuel circuit (Psec) tube, adjacent to the braze that attaches the Psec tube to the support block pad, and had propagated sufficient to induce a fuel leak.

The cause of this cracking has been identified as low cycle fatigue, due to the abrupt transition created by the brazed support block pad that is unable to slide as intended due to thermal loads, resulting in stresses that exceed the material fatigue capability of the top main fuel manifold and lower fuel manifold.

- (6) Do an ultrasonic inspection of the top main fuel manifold (1, [Figure 1](#)) and lower fuel manifold (2) for cracks in the pilot secondary fuel tube of the manifold assembly adjacent to the ten support block pads. Refer to paragraph 4., [APPENDIX - A](#) and as follows:
 - (a) If the ultrasonic inspection cannot be done on one of the brazed support block pad locations due to engine variation and possible clearance issues, do a class A FPI on the concerned brazed block location. Refer to the SPM, 70-32-03, SPOT-FLUORESCENT-PENETRANT INSPECTION or GENx-2B, Boeing 747-8 AMM, 70-11-06, MAINTENANCE PRACTICES, TASK 70-11-06-200-801-G00.
 - *Indications of 0.03 inch (0.8 mm) or less are permitted.

- (7) If you find cracks or leakage in the top main fuel manifold (1, [Figure 1](#)) and/or lower fuel manifold (2), replace the affected top main fuel manifold (1) and/or lower fuel manifold (2) as follows:
 - (a) For on-wing replacement of the top main fuel manifold (1, [Figure 1](#)), refer to GENx-2B S/B 73-0079.
 - (b) For replacement of the lower fuel manifold (2, [Figure 1](#)), you must remove the engine. Refer to GENx-2B S/B 73-0038.

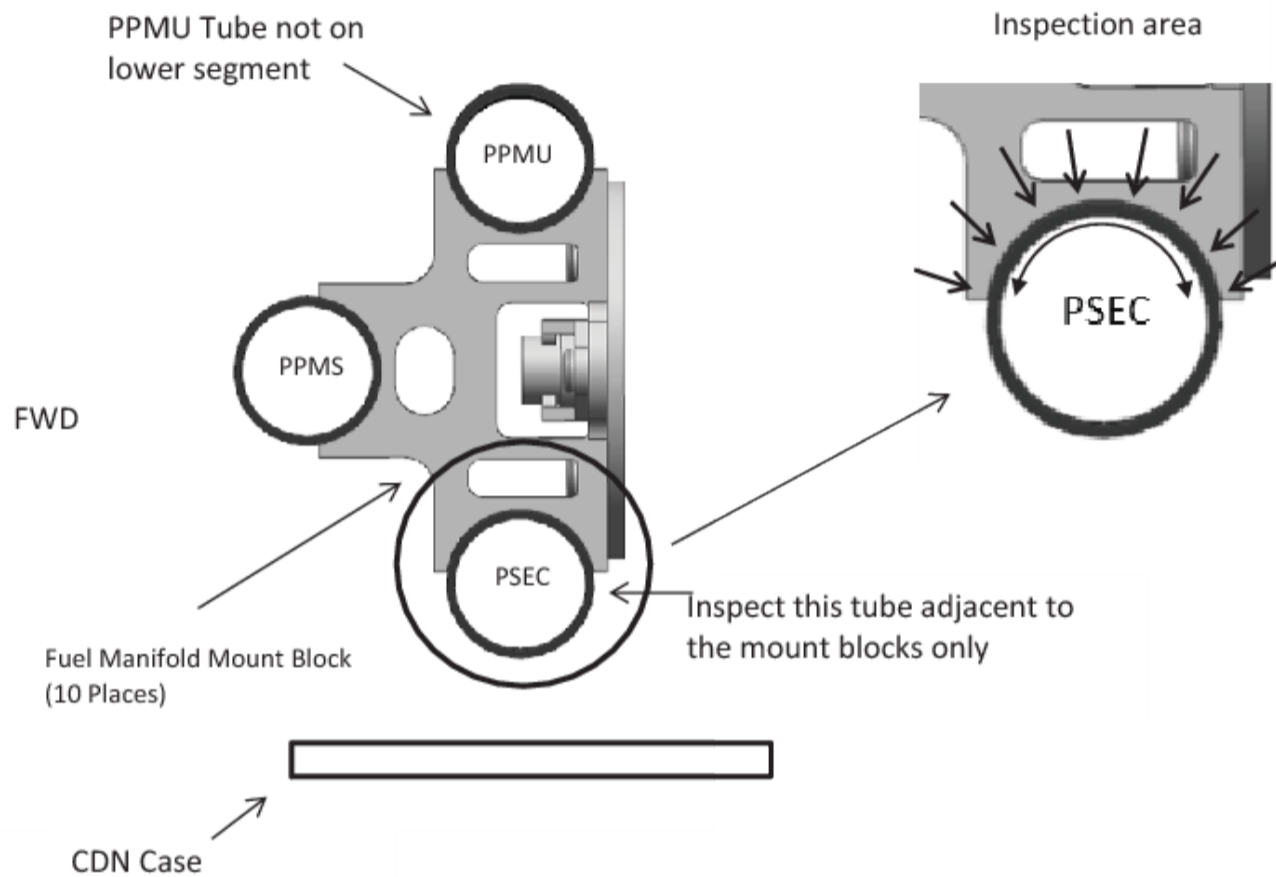
FIGURE 4 - FUEL MANIFOLD TUBE IDENTIFICATION AND INSPECTION AREA

Note: Only the Psec fuel tube inspection is required adjacent to the mount block locations.
